# STAC Alert

Alert Reference #: SA-0002-B

### Hazard: Loose Pin on Cougar Trolley 3.0 (p/n 4.957.0042.001)

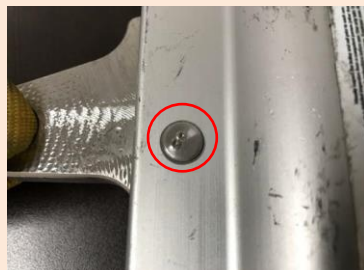
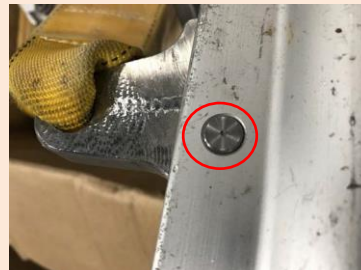
Trylon conducted a full investigation of the (6) affected Trolleys that were shipped back for inspection; this notice is a compilation of the findings of that investigation. Upon examination, it was noted that the returned Trolleys had 'dimple' markings on the end of the knurled pins. See the below pictures for examples of this mark (larger version of each image is available on the final pages of this document).

These marks indicate that the knurled pins were removed from the aluminum Trolley body during production and then re-used during final assembly of the Trolley. Although several trolleys bearing this mark have been checked by Trylon and found to be secure, and Trylon could not re-produce a loose pin condition through removal and reuse, there is a potential that the knurled pins could become loose with significant usage and rough handling.

STAC and Trylon would ask that all of your purchased *Cougar Trolley 3.0s* (p/n 4.957.0042.001) are inspected immediately for this dimple-mark on the pin. If no mark is present, your Trolley is not affected by this issue.

If, however, you discover dimple marking(s) on the pin of your Trolley, please remove it from service immediately and contact Trylon's Quality Manager Blake Niemi for direction ([blake.niemi@trylon.com](mailto:blake.niemi@trylon.com), 519-669-5421 x1265).

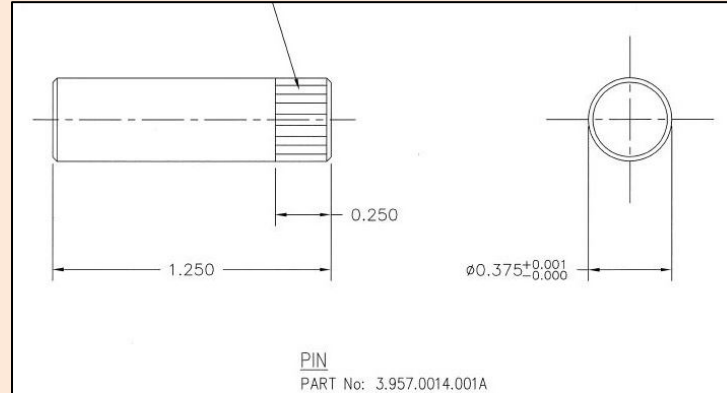
The problem is limited only to *Cougar Trolley 3.0s* with knurled pins bearing this dimple marking. Further, the potential for this marking has been traced back to a single batch of Trolleys assembled by Trylon in December 2016 – January 2017. **UPDATE: This issue is no longer limited to knurled pins bearing the dimple marking.**

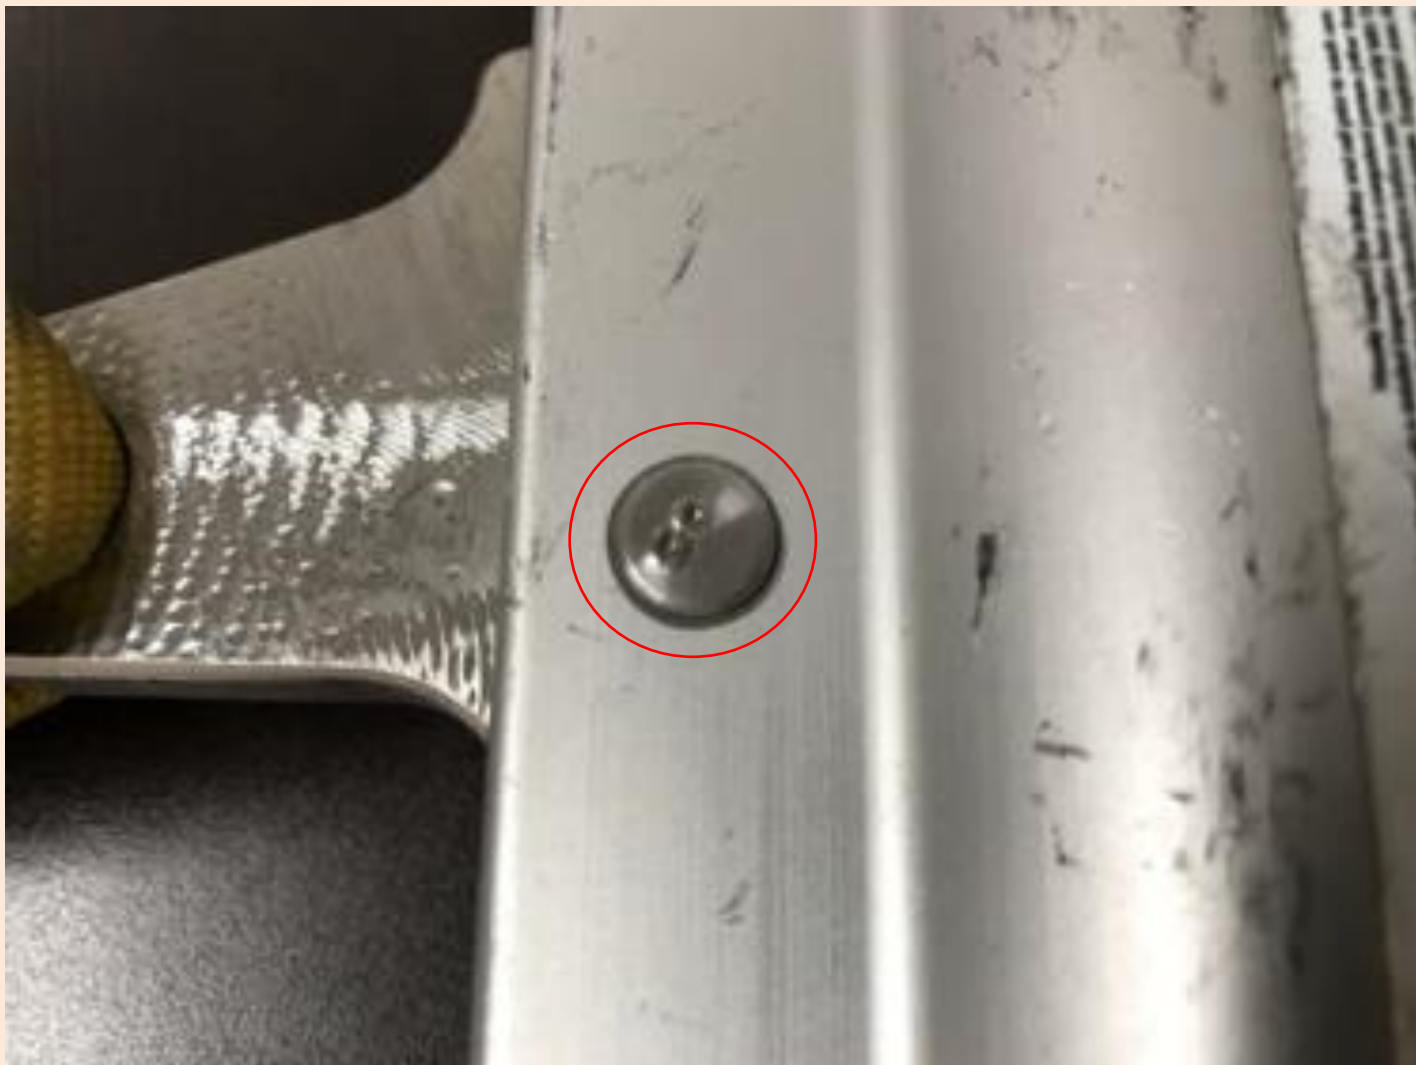
**IMAGE 1:** Example of dimple markings on Cougar Trolley 3.0 knurled pin

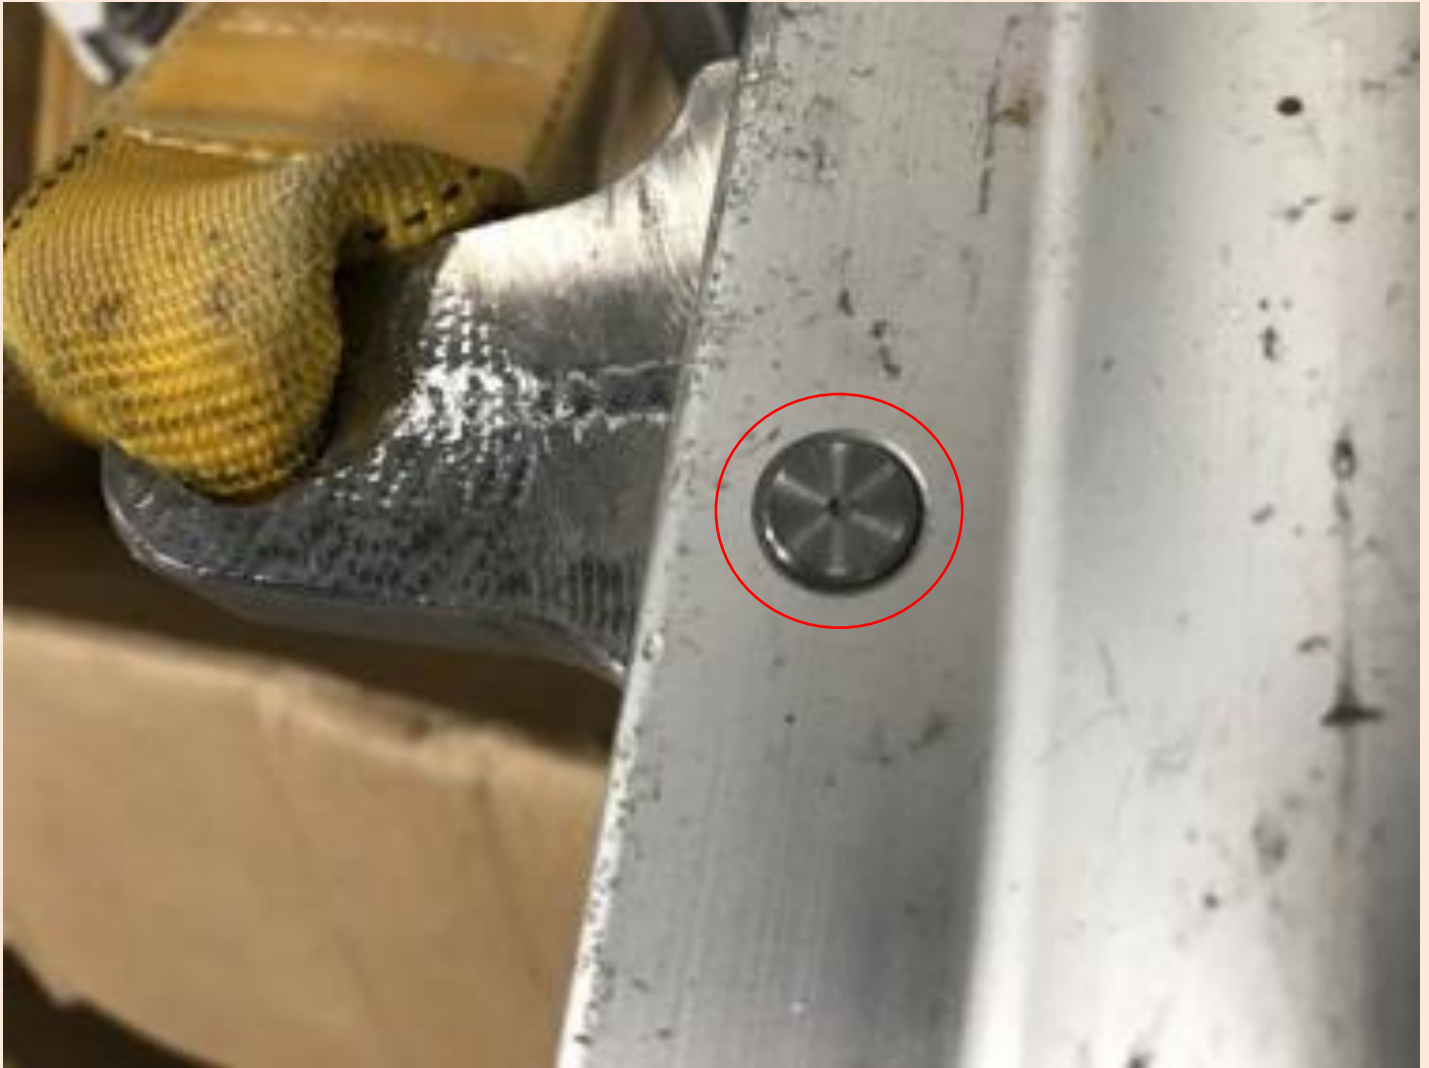
**IMAGE 2:** Additional example of dimple markings on Cougar Trolley 3.0 knurled
