# STAC Bulletin

**Tripole Vibration Issues –  
Inspection and Mitigation Recommendations**  
Ref. # SB-0001 February 16, 2018

## **Tripole Vibration Issues – Inspection and Mitigation Recommendations**

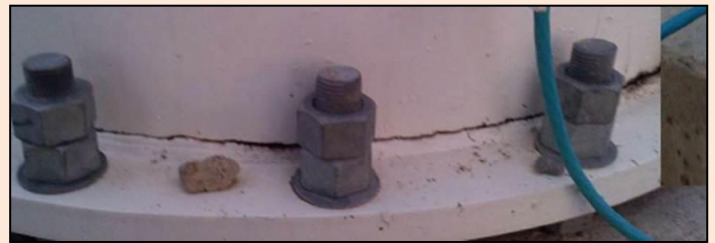
A shrouded tripole in Ontario on December 5th had a serious issue where the tripole had significant cracks at one of the tube legs at the base of the structure. Upon investigation, it was determined that these cracks had been caused by Galloping vibrations, which occur when the top of the structure exhibits a somewhat oblong or ovular motion in a direction that is at 90 degrees to that of the wind.

Cracked weld caused by galloping vibrations on a shrouded pole.

- Weld cracks
- Concrete foundation cracks
- Anchor bolt cracks
- Sheared bolts or excessive number of loose bolts
- If any cracks are discovered, discontinue all other work on or near the tower and take immediate action to repair the cracks under the direct supervision of a qualified engineer. Once all cracks are repaired, proceed to Recommendation 3 (Dynamic Analysis) and Recommendation 4 (Mitigation)
- If no cracks are discovered, complete inspection and proceed to Recommendation 3 (Dynamic Analysis) and Recommendation 4 (Mitigation)
- Note: even if there are no visible signs of cracking on or around the tower, it is possible that cracks and other effects of Galloping vibrations can manifest in the near future.

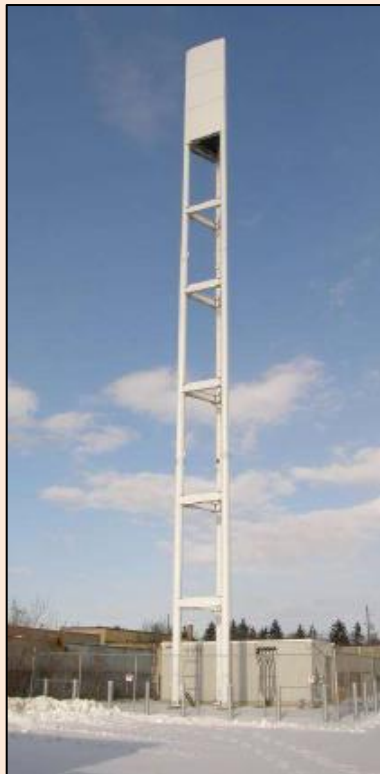
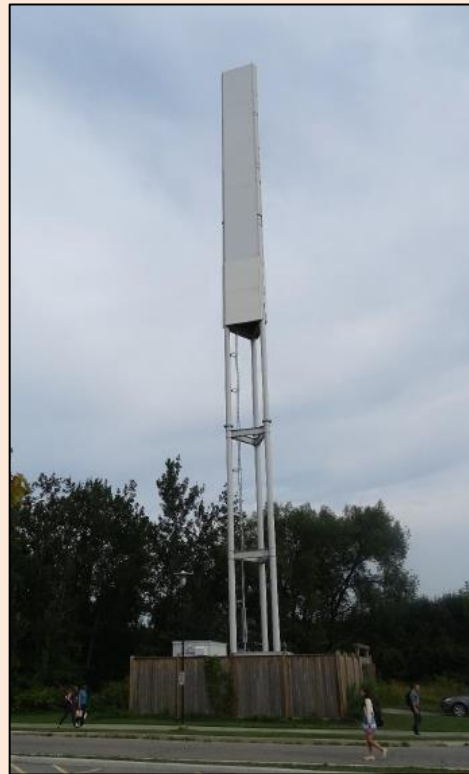
STAC recommends that site owners immediately assess their entire inventory of shrouded tripole towers to determine which, if any, have a shrouded portion that is equal or greater in height than 3X the width of the tripole's face. For example, a tower would be considered within this grouping if the tower face is 2.5 meters wide and there is a shroud that is 7.5 meters or longer in height.

The above images show two tripoles with shrouds of differing lengths. The shroud in the image on the right is clearly more than 3X as long as the tower's width, and would cause the tower to be susceptible to galloping vibrations.

Depending on the outcome of the results of Recommendation 3 (Dynamic Analysis), the responsible engineer may recommend mitigation solutions, including removing the shroud or installing a vibration dampening device (such as a tuned liquid dampener or a tuned mass dampener). While other solutions may be developed going forward, these are the only solutions that have been proven to be effective at this time as wind tunnel testing is required to demonstrate the efficiency of other hypothesized mitigation methods.
